## **FIELD INSPECTION**

Project Name: Mountain Valley Pipeline Date:Thursday, May 9, 2019

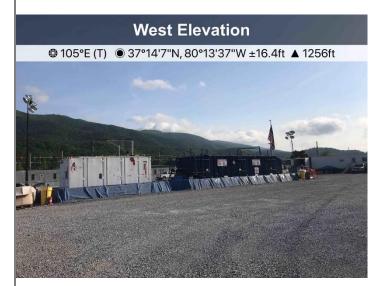
Fig. 1 Controls in place at PPY-006

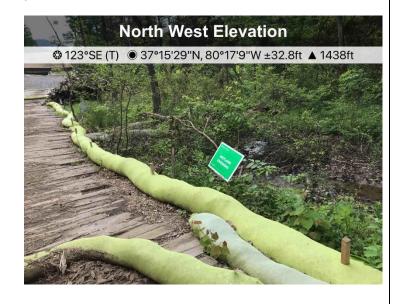
Fig. 4. At designated wetland W-F9-PFO, ECD's are in place.
